Restoring an Adobe Home

in Mora BY ILKA VILLARREAL

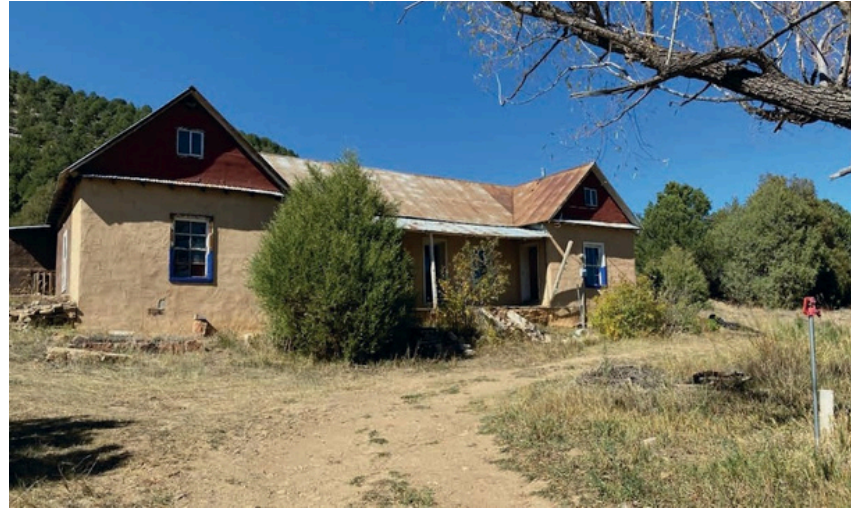
Old adobe farmhouse that has been renovated by Mark Schwartz

The home is believed to have been constructed in three distinct parts, each reflecting the era in which it was built. The oldest is the central rectangular section, featuring older-style window casings and thick 16-inch adobe walls dating to the early 1900s. A northern addition followed in the 1930s or '40s, introducing newer window casings, thinner adobe bricks and a gabled roofline with a small attic window. A third addition on the south side was added in the 1970s, mirroring the northern wing's style but constructed of cinder block.

Restoring the adobe has been a tremendous endeavor, drawing on early construction experience, invaluable guidance from the folks at Cornerstones, local craftspeople, neighbors and plenty of reading and YouTube videos. The first logical step was addressing the roof—the old bones of the farmhouse were strong, but it needed a new hat. A local roofer was brought in to replace it, preserving the original lines while adding insulation and new corrugated tin to match the historic material. Gutters were added for rainwater harvesting, and combined with excavation work, the new roof now protects both the foundation and walls from the elements.
